ENVIRONMENTAL MONITORING OF A DREDGING PROJECT WITH A FOCUS ON THE DEWATERING TREATMENT SYSTEM

L. Ferrans¹, W. Hogland²

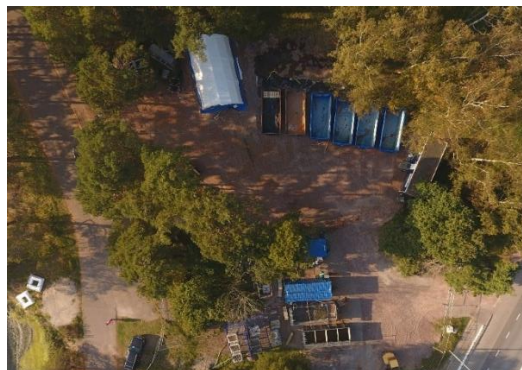
Figure 1. Dewatering site at Malmfjärden Bay. Photo ©: Kalmar Municipality

The turbidity of the bay water was measured by taking samples from the water body and analyzed with a turbidimeter. Regarding the dewatering system, the samples were taken manually from Oct 2020 to Aug 2021, collecting samples from the inlet three times per week and daily for the outlet of the geotubes. Sediment samples were taken manually from inside the bags. The samples were analyzed for nutrients, metals and oil index in an external laboratory.
